Rehabilitation of pipelines, an evaluation method with application to 3 trenchless technologies

J. van Vossen (KWR, NL), G.A.M. Mesman (KWR, NL), T. van den Brand (KWR, NL), J. Henzen (Heijmans, NL), M. Nooijen (BAM, NL), M. v.d. Wijst (BAM, NL), H. Vogelaar (WML, NL), R.F van Nieuwenhuijze (Brabant Water, NL), B. Jacobs (Vitens, NL)

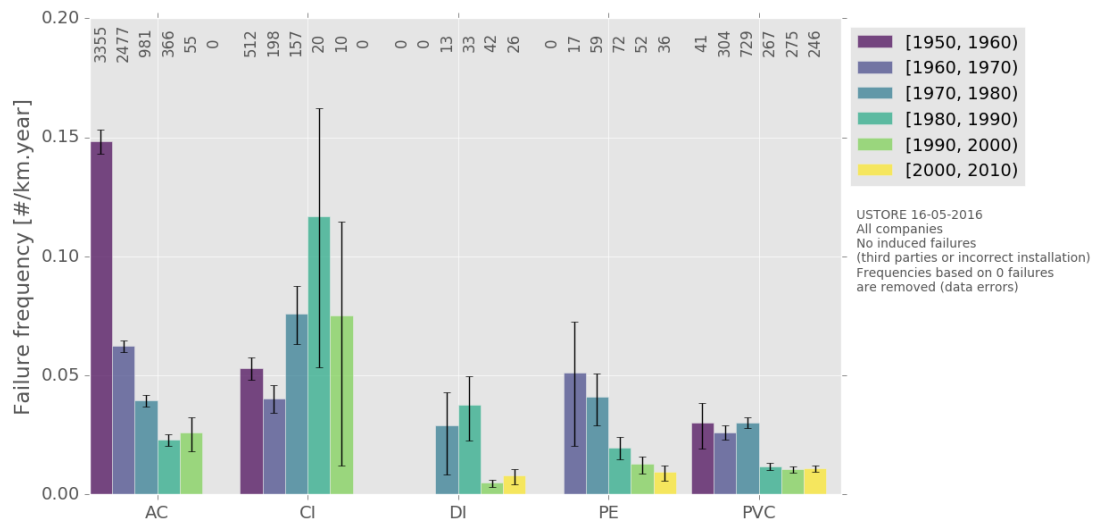
Figure 1 Failure frequencies of the different materials over the period of installation. The black line shows the error margin, based on the number of failures the analysis was based on compared to the total length of pipe for that material of that age. The numbers above the bars show the number of failures the analysis was based on.

In the Netherlands 8 out of 10 drinking water companies register their failure data according to uniform standards in a central web based database (USTORE) [3]. The failure frequencies of the different materials as a function of the period of installation are shown in Figure 1. Clearly, AC and CI show on average higher failure frequencies. The early asbestos cement pipes tend to fail in higher numbers than the younger pipes. As most of the failing pipes are not repaired, but replaced in the Netherlands, the low failure rate of the old cast iron pipes is due to replacing the bad quality pipes in the total cohort cast iron. The focus on replacement in the Netherlands is therefore on old AC and CI pipes.

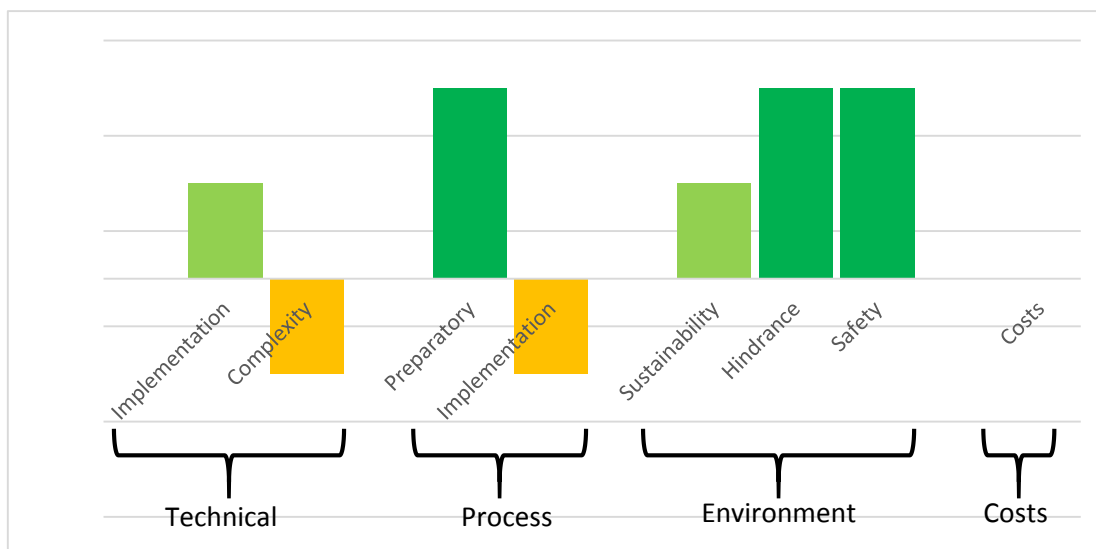
Figure 2 Example of effect diagram, with red indicating the technique performs poor compared to a traditional open-cut approach, orange (moderate), yellow (equivalent), light green (reasonable) and dark green (much better).

The experiences with individual pilots have shown that for a single pilot location a rating of environmental aspects and costs leads to unwanted results, because these elements are very much locally determined. Therefore, individual pilot locations were rated only for technical and process related aspects and analyzed, but not rated for environmental aspects and costs. The full rating is therefore only possible when evaluating several projects at once or for scenario calculations. The full rating is presented in an effect-diagram, with different colors representing performance. An example is shown in Figure 2.

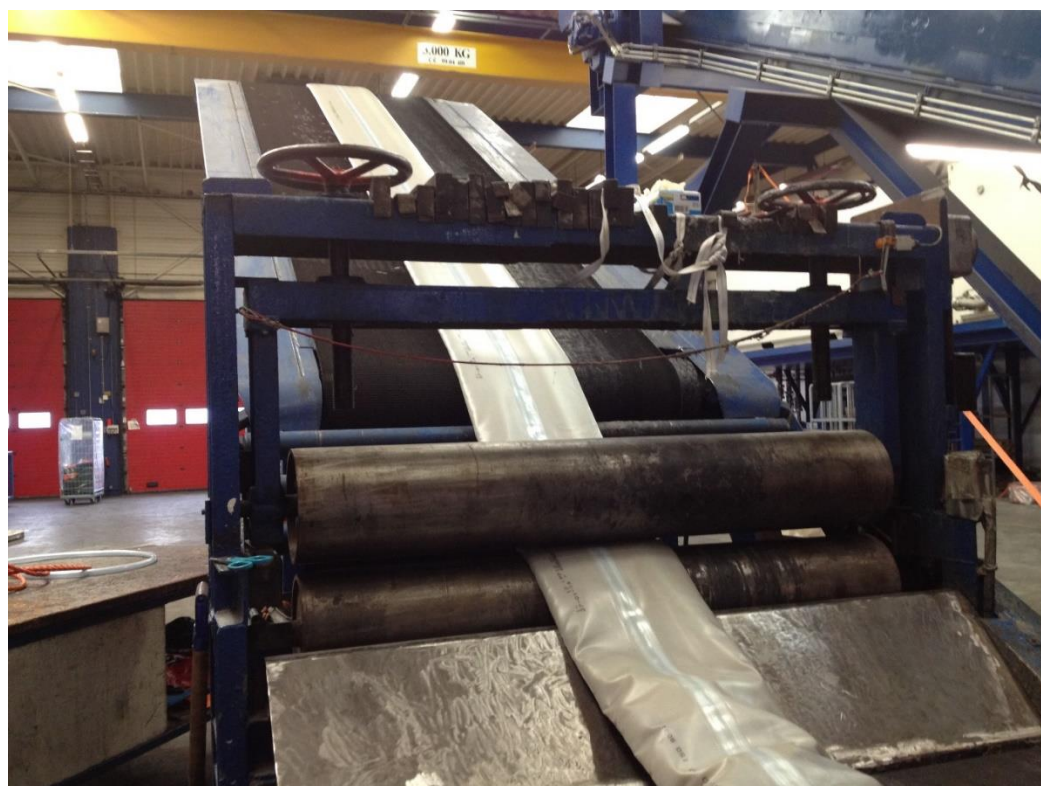
Figure 1 Impregnating a liner with resin.

This is a Cured in Place Pipe (CIPP) in which a resin impregnated liner (Figure 3) is pulled into a pipe after which the liner is cured using high temperatures that initiate and maintain a chemical reaction turning the liner and resin into a fully constructive new pipe. This type of trenchless technology is quite common in sewers since decades, but until recent no Dutch certified technology was available for drinking water. To obtain the required certification a new resin was developed that does not impact the drinking water quality and still maintains the required characteristics to ensure a strong liner.

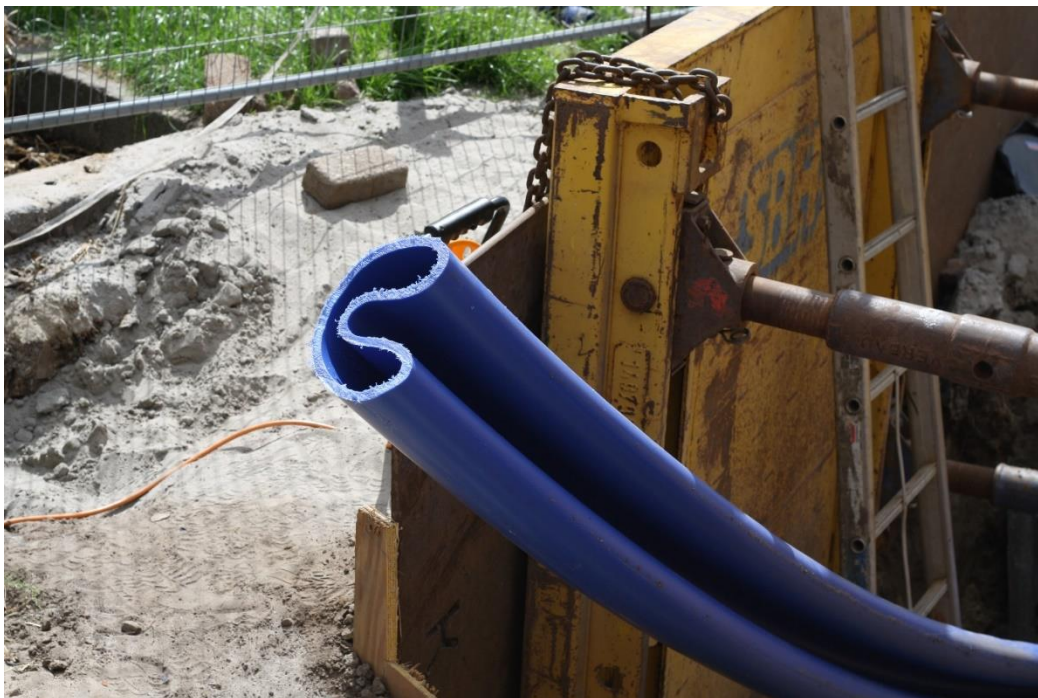
Figure 2 Application of Compact Pipe in Zwaagwesteinde, Friesland.

This is a close-fit technique in which a fully constructive, pre-folded PE-liner is pulled through an existing pipe and then reshaped back into its original shape. This technique was applied to a 300 mm CI pipe in Zwaagwesteinde (June 2016, Figure

4) (<http://nl.wavin.com/web/oplossingen/drinkwater/hoofdnetwerk/close-fit-lining-compact-pipe-3.htm>). The pipe is a bitumen coated CI pipe to ensure continuous supply in situations with increased demand or problems with the regular supply route. The water in this specific pipe remains still for extended periods of time. During these periods PAH's were released from the bitumen coating. To ensure water quality the pipe needs extensive flushing before operational use. The Compact Pipe should resolve this problem. A specific research question in this pilot concerned whether the permeable PE liner would sufficiently reduce the water quality problem.
